**Flood Control Project Maintenance
Levee Inspections****LMA District Cover Sheet
Spring 2016 Levee Inspection Results****Reclamation District No. 0554 Walnut Grove**

Levee Inspection Report By Mile - Spring 2016

Reclamation District No. 0554 Walnut Grove

Waterway	Bank	Unit Miles	Inspection Start/End	Inspector
Unit No. 01 Sacramento River	Left	1.13	03/16/2016 03/16/2016	Herman Phillips

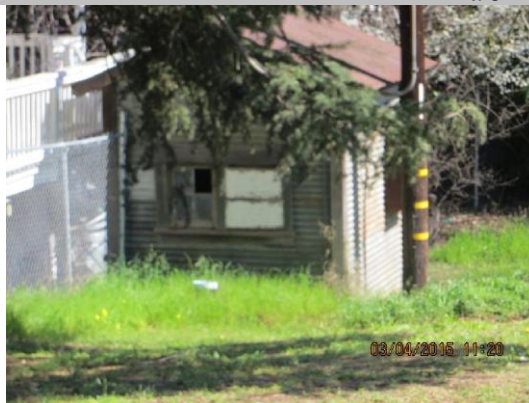
Photo 1 of 2 : UCIP_SP_2016_43726_73282.jpg

LM Start	0.02	Rating **	M	Issue No.	58
LM End	0.02	Issue Type +	En	Location *	WS
Category	Supplemental			GPS Latitude/Longitude	
				Start	End
Item	DWR UCIP Field Study			38.249553 °	38.249553 °
				-121.509954 °	-121.509954 °
DWR ID					
Comment Code					
Inspector Comment					
FS_ID:43726 DS_ID:18976 EP_NO: N/A Repair Type: Non-Urgent Crossing Status: Indicator Found UCIP Comments: Need to verify status of crossing with town of Locke. FIELD_STRUCT_DESC: Waterline of unknown diameter through the levee at unknown depth. Likely a 1 or 2-inch galvanized iron pipe. Crosses levee just south of concrete block pumphouse on WS shoulder and terminates at well house off LS toe. Gatevalve next to corner of pumphouse off LS toe. Drawings depicting approximate location available in PN: 12944. FS Date: 3/4/2015 4:49:00 PM

Pumphouse off LS toe.

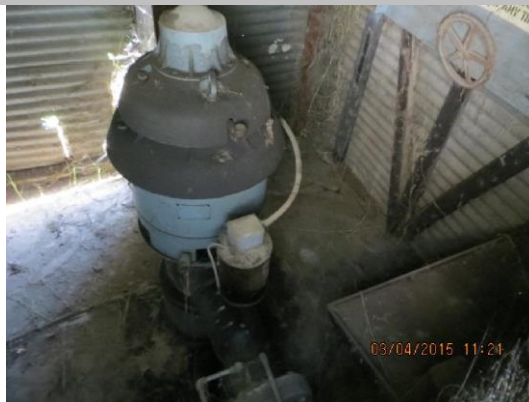
Photo 2 of 2 : UCIP_SP_2016_43726_73281.jpg

Pump over well inside pumphouse on LS toe.

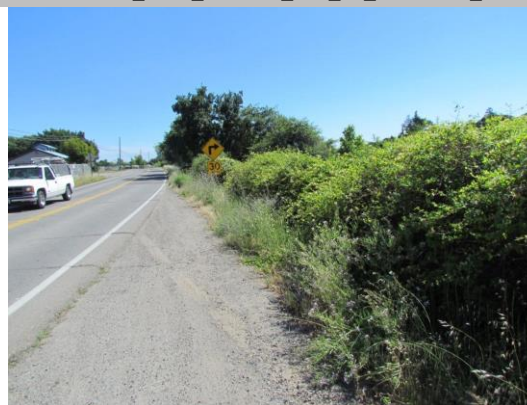
Photo 1 of 1 : SP_2016_RD0554_176_32_20160316_00053.jpg

LM Start	0.05	Rating **	M	Issue No.	32
LM End	0.39	Issue Type +	Ma	Location *	WS
Category	Earthen Levee			GPS Latitude/Longitude	
				Start	End
Item	Vegetation			38.249050 °	38.244495 °
				-121.509977 °	-121.511830 °
DWR ID	DWR_RD0554_01_f_2015_32				
Comment Code					
V1 : Control annual grass and weeds on the levee slopes and easements.					
Inspector Comment					
This section on the waterside has growth covering the fence at levee mile 0.05 and vegetation on the slope.

RD 554 Levee mile 0.05 waterside shoulder.

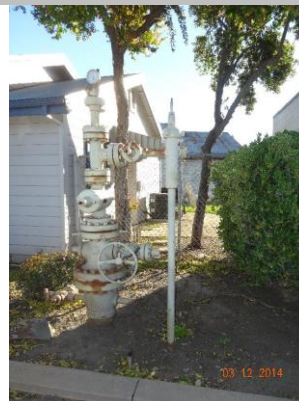
Photo 1 of 1 : UCIP_SP_2016_42146_58463.jpg

LM Start	0.08	Rating **	U	Issue No.	46
LM End	0.08	Issue Type +	En	Location *	WS
Category	Supplemental			GPS Latitude/Longitude	
				Start	End
Item	DWR UCIP Field Study			38.248643 °	38.248643 °
				-121.509850 °	-121.509850 °
DWR ID					
Comment Code					
Inspector Comment					
FS_ID:42146					
DS_ID:20946					
EP_NO: 5607					
Repair Type: Urgent					
Crossing Status: Indicator Found					
UCIP Comments: No markers. Valves abandoned on landward side--					
need to contact owner to determine status of crossing.					
FIELD_STRUCT_DESC: Abandoned three 4-inch steel petroleum pipes					
through the levee, 22.5 feet below the crown. Pipes placed in 8-inch					
pipe casing through the levee and plugged with concrete. Abandoned					
under Permit No. 5607 (1966).					
FS Date: 3/12/2014

Valves located on landward side.

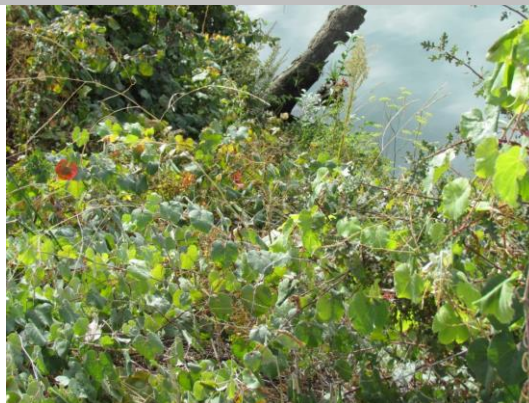
Photo 1 of 1 : SP_2016_RD0554_176_11_20160223_00003.jpg

LM Start	0.10	Rating **	U	Issue No.	11
LM End	0.10	Issue Type +	Ma	Location *	WS
Category	Earthen Levee			GPS Latitude/Longitude	
				Start	End
Item	Erosion / Bank Caving			38.248262 °	38.248262 °
				-121.509901 °	-121.509901 °
DWR ID	DWR_RD0554_01_s_2014_11				
Comment Code					
E1 : Note and monitor erosion site.					
Inspector Comment					
This is not a new erosion site, repairs are needed. One tree has fallen into the Sac River at the erosion site. This site can be seen better from the river by boat. The wild grapes blocks the view from the waterside shoulder looking down the slope. There was no new picture taken of this issue.

Erosion on waterside toe dead tree fallen at erosion site.

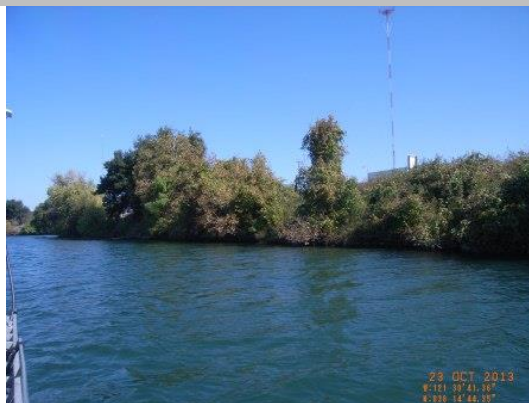
Photo 1 of 2 : SP_2016_RD0554_176_1_20160223_00001.jpg

LM Start	0.26	Rating **	M	Issue No.	1
LM End	0.36	Issue Type +	Ma	Location *	WS
Category	Supplemental			GPS Latitude/Longitude	
				Start	End
Item	2015 USACE Erosion Survey, DRAFT			38.246222 °	38.245017 °
				-121.510878 °	-121.511740 °
DWR ID	DWR_RD0554_01_s_2016_1				
Comment Code					
Inspector Comment					
2009 - Tension cracks on road on top of levee. Erosion into the levee slope and mass failure. 2013 - Short vertical sections at bank toe. 2015: No observed changes. [2015 Site ID: SAC_27-0_L]

USACE 2013 Photo #1

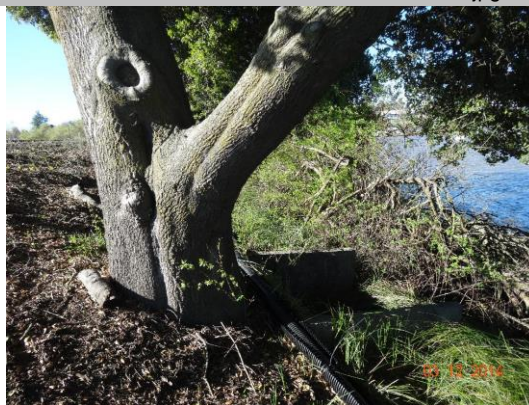
Photo 2 of 2 : UCIP_SP_2016_32018_58468.jpg

LM Start	0.27	Rating **	M	Issue No.	39
LM End	0.27	Issue Type +	En	Location *	WS
Category	Supplemental			GPS Latitude/Longitude	
				Start	End
Item	DWR UCIP Field Study			38.246093 °	38.246093 °
				-121.510731 °	-121.510731 °
DWR ID					
Comment Code					
Inspector Comment					
FS_ID:32018					
DS_ID:20897					
EP_NO: N/A					
Repair Type: Non-Urgent					
Crossing Status: Indicator Found					
UCIP Comments: Unable to determine status of crossing--was crossing removed during erosion repair site in 2007-2009? Need to coordinate with LMA or owner to obtain additional information about crossing.					
FIELD_STRUCT_DESC: Inactive 6-inch pipe through the levee, 1.0-foot below the crown. Concrete pump pad on the waterward slope. O+M manual entry at RM 27.00, 1959.					
FS Date: 3/12/2014

Concrete vault located on waterward side. Site is a erosion repair site.

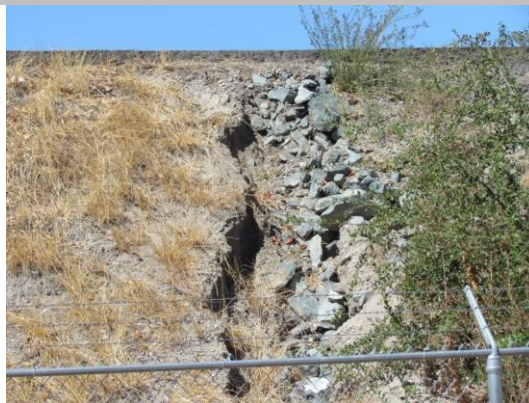
Photo 1 of 1 : SP_2016_RD0554_176_13_20160223_00004.jpg

LM Start	0.32	Rating **	U	Issue No.	13
LM End	0.32	Issue Type +	Ma	Location *	LS
Category	Earthen Levee			GPS Latitude/Longitude	
				Start	End
Item	Erosion / Bank Caving			38.245389 °	38.245389 °
				-121.511085 °	-121.511085 °
DWR ID	DWR_RD0554_01_s_2014_13				
Comment Code					
E2 : Schedule repair of erosion site prior to the next inspection.					
Inspector Comment					
The District has scheduled repairs this season.

This erosion along the landside levee slope is not new, it was reported two years ago.

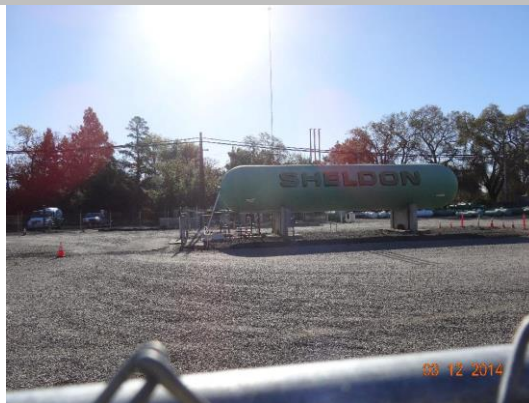
Photo 1 of 1 : UCIP_SP_2016_42143_60800.jpg

LM Start	0.33	Rating **	U	Issue No.	43
LM End	0.33	Issue Type +	En	Location *	LS
Category	Supplemental			GPS Latitude/Longitude	
				Start	End
Item	DWR UCIP Field Study			38.245295 °	38.245295 °
				-121.511274 °	-121.511274 °
DWR ID					
Comment Code					
Inspector Comment					
FS_ID:42143 DS_ID:20922 EP_NO: N/A Repair Type: Urgent Crossing Status: Indicator Found UCIP Comments: No markers found. Need to contact owner to determine status of crossing. Unable to confirm if crossings are still active or if they cross levee. FIELD_STRUCT_DESC: 1 of 3: 3-inch steel fuel line through the levee, 2.7 feet below the crown. (USACE-1959). This entry matches the Drainage or Irrigation Structure referenced in O&M manual (RM 27.20). FS Date: 3/12/2014

Tank found on landward side.

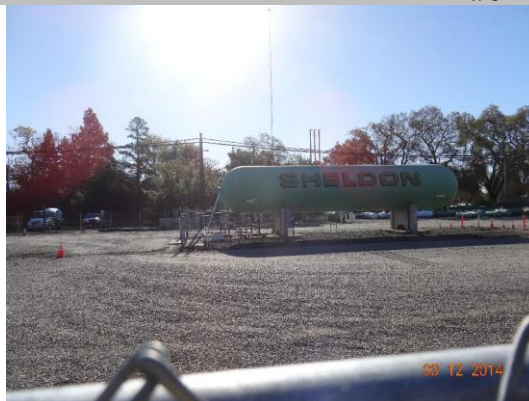
Photo 1 of 1 : UCIP_SP_2016_42144_60801.jpg

LM Start	0.33	Rating **	U	Issue No.	44
LM End	0.33	Issue Type +	En	Location *	LS
Category	Supplemental			GPS Latitude/Longitude	
				Start	End
Item	DWR UCIP Field Study			38.245295 °	38.245295 °
				-121.511274 °	-121.511274 °
DWR ID					
Comment Code					
Inspector Comment					
FS_ID:42144 DS_ID:20932 EP_NO: N/A Repair Type: Urgent Crossing Status: Indicator Found UCIP Comments: No markers found. Need to contact owner to determine status of crossing. Unable to confirm if crossings are still active or if they cross levee. FIELD_STRUCT_DESC: 2 of 3: 3-inch steel fuel line through the levee, 2.7 feet below the crown. (USACE-1959). This entry matches the Drainage or Irrigation Structure referenced in O&M manual (RM 27.20). FS Date: 3/12/2014

Fuel tank located on landward side.

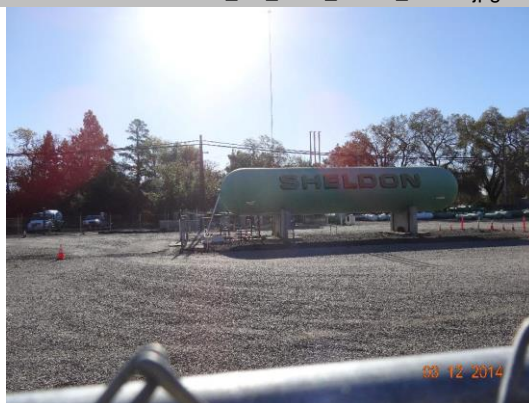
Photo 1 of 1 : UCIP_SP_2016_42145_60802.jpg

LM Start	0.33	Rating **	U	Issue No.	45
LM End	0.33	Issue Type +	En	Location *	LS
Category	Supplemental			GPS Latitude/Longitude	
				Start	End
Item	DWR UCIP Field Study			38.245295 °	38.245295 °
				-121.511274 °	-121.511274 °
DWR ID					
Comment Code					
Inspector Comment					
FS_ID:42145 DS_ID:20933 EP_NO: N/A Repair Type: Urgent Crossing Status: Indicator Found UCIP Comments: No markers. Need to contact owner to determine status of crossing. Unable to confirm if crossings are still active or if they cross levee. FIELD_STRUCT_DESC: 3 of 3: 3-inch steel fuel line through the levee, 2.7 feet below the crown. (USACE-1959). This entry matches the Drainage or Irrigation Structure referenced in O&M manual (RM 27.20). FS Date: 3/12/2014

Fuel tank located on landward side.

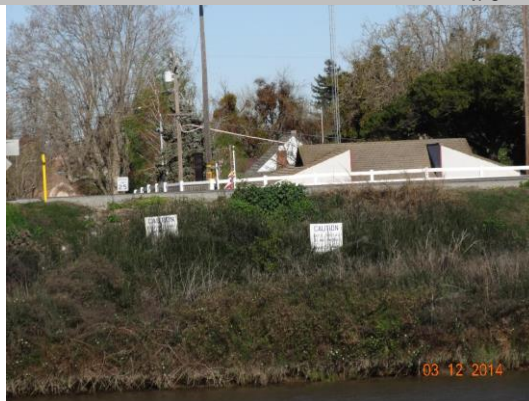
Photo 1 of 2 : UCIP_SP_2016_43694_58063.jpg

Comment Code					
Inspector Comment					
FS_ID:43694 DS_ID:20899 EP_NO: 5429 Repair Type: Non-Urgent Crossing Status: Indicator Found UCIP Comments: Signs of open cut along crossing--no markers visible on waterward or landward side. Large across channel on right bank berm indicating cable through levee. FIELD_STRUCT_DESC: Four 4-inch iron conduits through the levee, at various depths below the crown (3.0-4.9 feet). Each conduit encases a shielded telephone cable. Concrete cutoff wall around pipes on landward levee shoulder. Riser pole off the landward levee toe. (Permit No. 5429-1967) Replacement telephone conduits were pulled through iron conduits under Permit No. 13417 (1983). FS Date: 3/4/2015

Signs for conduits visible on right bank across channel. Conduits cross left bank, channel, and right bank.

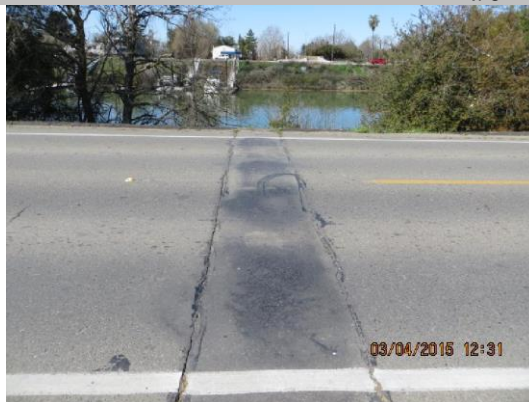
Photo 2 of 2 : UCIP_SP_2016_43694_73221.jpg

View of waterside from landside shoulder. Cuts in pavement indicate presence of pipe trench across levee.

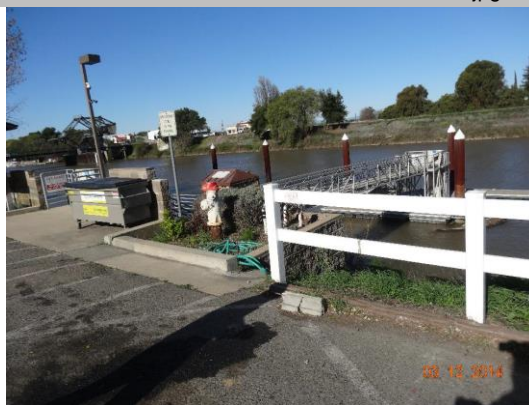
Photo 1 of 2 : UCIP_SP_2016_43734_58085.jpg

Comment Code					
Inspector Comment					
FS_ID:43734 DS_ID:20901 EP_NO: 11155 Repair Type: Non-Urgent Crossing Status: Indicator Found UCIP Comments: Multiple crossings at same location--unable to confirm if crossing matches details under permit 11155. Need to contact owner to obtain additional information about crossing status. FIELD_STRUCT_DESC: 1 of 3: 6-inch pipe through the levee, 5.5 feet below the crown. Pipe retained under ABO No. 11155 (1975). Pipe originally included in O+M manual, 1959, at RM 26.75. Fire hydrant on WS shoulder and valve in cut visible in roadway. Electrical utility box on LS shoulder. Electrical lines visible on WS at ramp. FS Date: 3/12/2014

Multiple lines through levee crown visible on waterward shoulder.

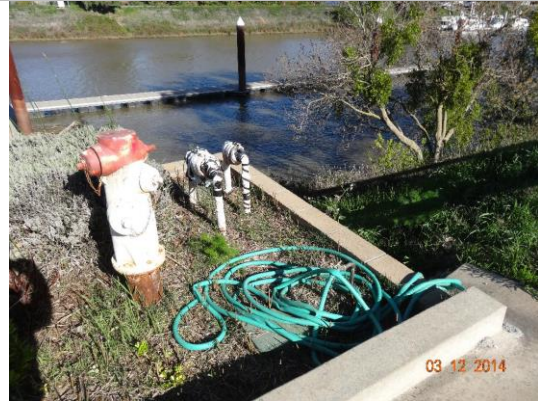
Photo 2 of 2 : UCIP_SP_2016_43734_58083.jpg

Comment Code					
Inspector Comment					
FS_ID:43734 DS_ID:20901 EP_NO: 11155 Repair Type: Non-Urgent Crossing Status: Indicator Found UCIP Comments: Multiple crossings at same location--unable to confirm if crossing matches details under permit 11155. Need to contact owner to obtain additional information about crossing status. FIELD_STRUCT_DESC: 1 of 3: 6-inch pipe through the levee, 5.5 feet below the crown. Pipe retained under ABO No. 11155 (1975). Pipe originally included in O+M manual, 1959, at RM 26.75. Fire hydrant on WS shoulder and valve in cut visible in roadway. Electrical utility box on LS shoulder. Electrical lines visible on WS at ramp. FS Date: 3/12/2014

Lines visible on waterward side.

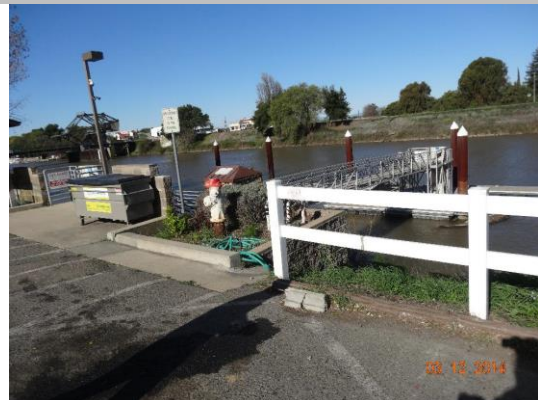
Photo 1 of 2 : UCIP_SP_2016_43735_58097.jpg

Comment Code					
Inspector Comment					
FS_ID:43735					
DS_ID:20937					
EP_NO: 11155					
Repair Type: Non-Urgent					
Crossing Status: Indicator Found					
UCIP Comments: Multiple crossings at same location--unable to confirm if crossing matches details under permit 11155. Need to contact owner to obtain additional information about crossing status.					
FIELD_STRUCT_DESC: 2 of 3: 6-inch pipe through the levee, 5.5 feet below the crown. Pipe retained under ABO No. 11155 (1975).Pipe originally included in O+M manual, 1959, at RM 26.75. Fire hydrant on WS shoulder and valve in cut visible in roadway. Electrical utility box on LS shoulder. Electrical lines visible on WS at ramp.					
FS Date: 3/5/2015

Multiple crossing visible on waterward shoulder.

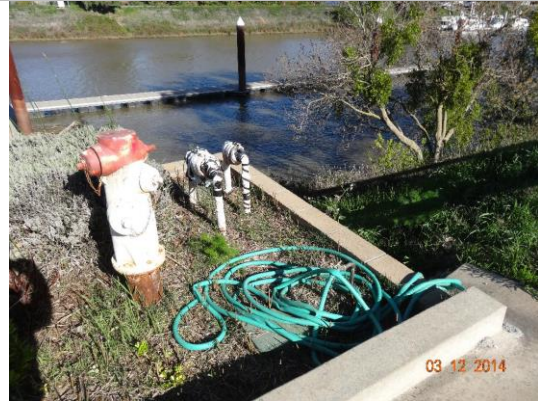
Photo 2 of 2 : UCIP_SP_2016_43735_58095.jpg

Comment Code					
Inspector Comment					
FS_ID:43735 DS_ID:20937 EP_NO: 11155 Repair Type: Non-Urgent Crossing Status: Indicator Found UCIP Comments: Multiple crossings at same location--unable to confirm if crossing matches details under permit 11155. Need to contact owner to obtain additional information about crossing status. FIELD_STRUCT_DESC: 2 of 3: 6-inch pipe through the levee, 5.5 feet below the crown. Pipe retained under ABO No. 11155 (1975).Pipe originally included in O+M manual, 1959, at RM 26.75. Fire hydrant on WS shoulder and valve in cut visible in roadway. Electrical utility box on LS shoulder. Electrical lines visible on WS at ramp. FS Date: 3/5/2015

Crossings visible on waterward side.

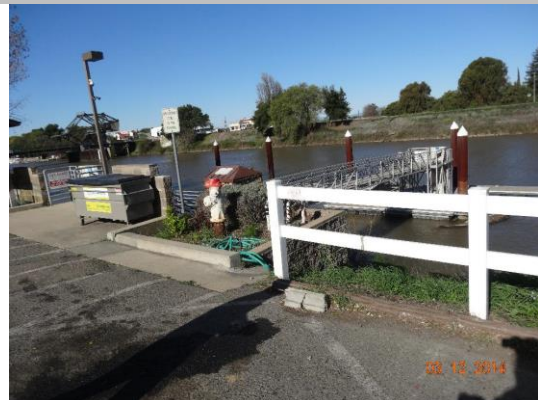
Photo 1 of 2 : UCIP_SP_2016_43736_58091.jpg

Comment Code					
Inspector Comment					
FS_ID:43736					
DS_ID:20938					
EP_NO: 11155					
Repair Type: Non-Urgent					
Crossing Status: Indicator Found					
UCIP Comments: Multiple crossings at same location--unable to confirm if crossing matches details under permit 11155. Need to contact owner to obtain additional information about crossing status.					
FIELD_STRUCT_DESC: 3 of 3: 6-inch pipe through the levee, 10.5 feet below the crown. Pipe retained under ABO No. 11155 (1975).Pipe originally included in O+M manual, 1959, at RM 26.75. Fire hydrant on WS shoulder and valve in cut visible in roadway. Electrical utility box on LS shoulder. Electrical lines visible on WS at ramp.					
FS Date: 3/5/2015

View of multiple crossings through levee.

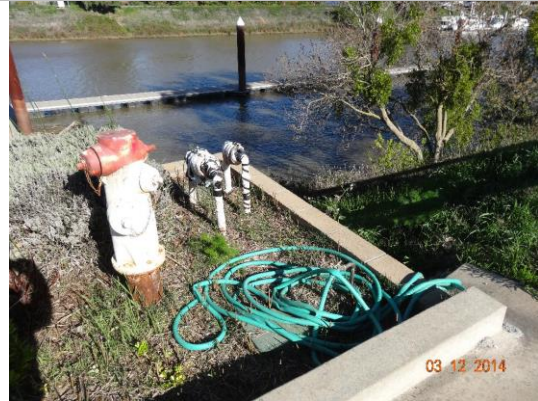
Photo 2 of 2 : UCIP_SP_2016_43736_58089.jpg

Comment Code					
Inspector Comment					
FS_ID:43736 DS_ID:20938 EP_NO: 11155 Repair Type: Non-Urgent Crossing Status: Indicator Found UCIP Comments: Multiple crossings at same location--unable to confirm if crossing matches details under permit 11155. Need to contact owner to obtain additional information about crossing status. FIELD_STRUCT_DESC: 3 of 3: 6-inch pipe through the levee, 10.5 feet below the crown. Pipe retained under ABO No. 11155 (1975).Pipe originally included in O+M manual, 1959, at RM 26.75. Fire hydrant on WS shoulder and valve in cut visible in roadway. Electrical utility box on LS shoulder. Electrical lines visible on WS at ramp. FS Date: 3/5/2015

Crossings visible on waterward shoulder.

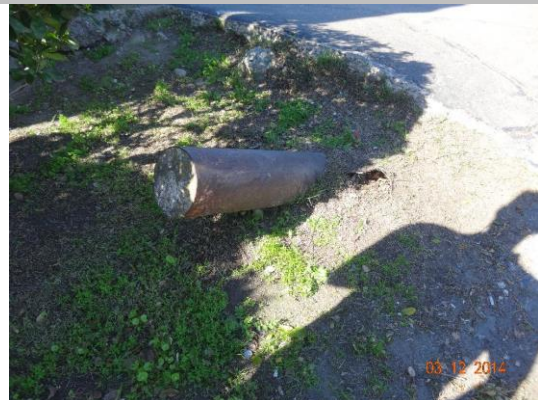
Photo 1 of 1 : UCIP_SP_2016_32020_58473.jpg

LM Start	0.60	Rating **	M	Issue No.	40
LM End	0.60	Issue Type +	En	Location *	WS
Category	Supplemental			GPS Latitude/Longitude	
				Start	End
Item	DWR UCIP Field Study			38.242101 °	38.242101 °
				-121.514086 °	-121.514086 °
DWR ID					
Comment Code					
Inspector Comment					
FS_ID:32020 DS_ID:20912 EP_NO: 11154 Repair Type: Non-Urgent Crossing Status: Indicator Found UCIP Comments: Unable to confirm if this pipe section is the same one listed under 11154. Need to contact owner to determine status and obtain additional information about crossing. FIELD_STRUCT_DESC: 8-inch pipe through the levee, 9.8 feet below the crown. Pump on LS toe. Included in O+M manual at RM 26.66. Pipe retained under ABO No. 11154 (1975). FS Date: 3/12/2014

Steel pipe filled with concrete visible on landward shoulder.

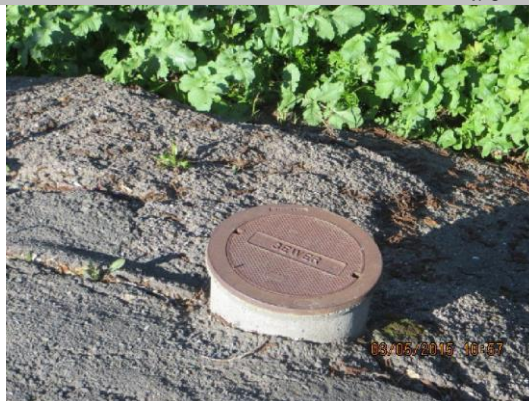
Photo 1 of 2 : UCIP_SP_2016_43805_73320.jpg

FS_ID:43805
DS_ID:25080
EP_NO: N/A
Repair Type: Non-Urgent
Crossing Status: Found
UCIP Comments: No permit found. Further investigation required.
FIELD_STRUCT_DESC: 4-inch Cast iron Sewer pipe through the levee at an unknown depth. Pipe visible on bridge. Sewer cleanout on WS shoulder and cut in pavement visible in roadway. (Permit No. 870, 1941)
FS Date: 3/5/2015

Sewer cleanout on WS shoulder.

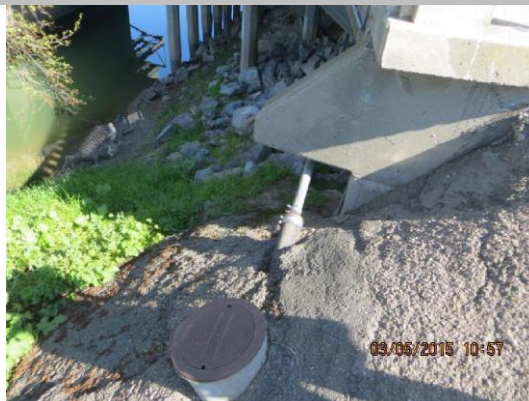
Photo 2 of 2 : UCIP_SP_2016_43805_73321.jpg

Pipe visible at bridge on WS shoulder.

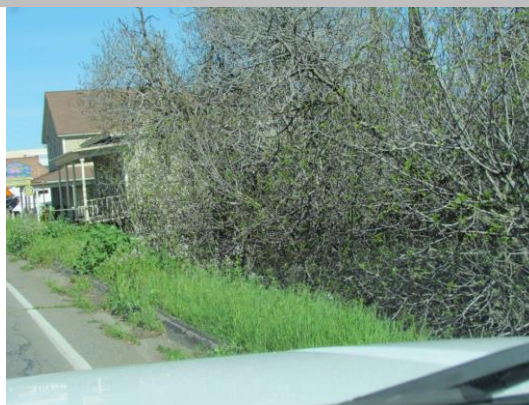
Photo 1 of 1 : SP_2016_RD0554_176_20_20160316_00054.jpg

Woody tree growth on the landside shoulder and slope. Also tall grasses at this location.

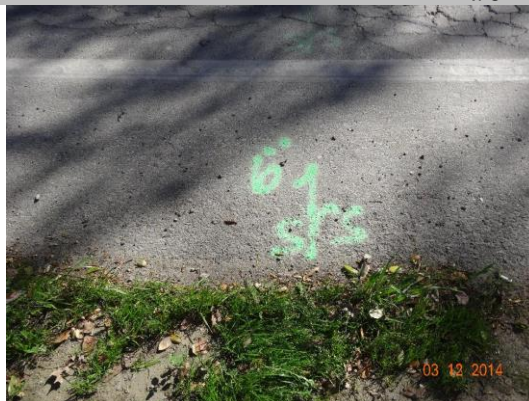
Photo 1 of 2 : UCIP_SP_2016_32021_58475.jpg

LM Start	0.89	Rating **	M	Issue No.	41
LM End	0.89	Issue Type +	En	Location *	LS
Category	Supplemental			GPS Latitude/Longitude	
				Start	End
Item	DWR UCIP Field Study			38.238595 °	38.238595 °
				-121.516945 °	-121.516945 °
DWR ID					
Comment Code					
Inspector Comment					
FS_ID:32021 DS_ID:20941 EP_NO: N/A Repair Type: Non-Urgent Crossing Status: Indicator Found UCIP Comments: Unable to confirm how many sewer lines cross levee. Desk study shows 2 crossings 4-inch not 6 inch. Need to contact owner to confirm status of crossing. FIELD_STRUCT_DESC: 1 of 2: 4-inch clay sewer pipe through the levee, 10.2 feet below the crown. (USACE-1959). This entry matches the Drainage or Irrigation Structure referenced in O&M manual (RM 26.50). FS Date: 3/12/2014 2:06:00 PM

Underground service alert (USA) markers confirming sewer line.

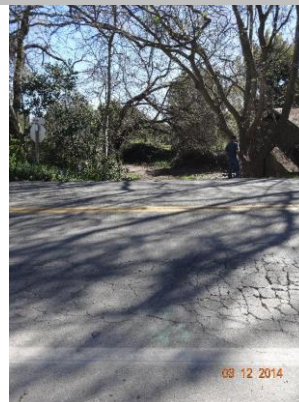
Photo 2 of 2 : UCIP_SP_2016_32021_58474.jpg

View of levee crown.

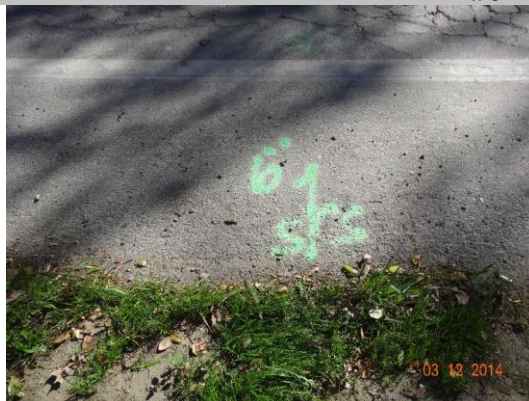
Photo 1 of 2 : UCIP_SP_2016_32022_58480.jpg

LM Start	0.89	Rating **	M	Issue No.	42
LM End	0.89	Issue Type +	En	Location *	LS
Category	Supplemental			GPS Latitude/Longitude	
				Start	End
Item	DWR UCIP Field Study			38.238595 °	38.238595 °
				-121.516945 °	-121.516945 °
DWR ID					
Comment Code					
Inspector Comment					
FS_ID:32022 DS_ID:20942 EP_NO: N/A Repair Type: Non-Urgent Crossing Status: Indicator Found UCIP Comments: Unable to confirm how many sewer lines cross levee. Desk study shows 2 crossings 4-inch not 6 inch. Need to contact owner to confirm status of crossing. FIELD_STRUCT_DESC: 2 of 2: 4-inch clay sewer pipe through the levee, 10.2 feet below the crown. (USACE-1959). This entry matches the Drainage or Irrigation Structure referenced in O&M manual (RM 26.50). FS Date: 3/12/2014

Underground service alert (USA) marker on waterward shoulder for sewer line.

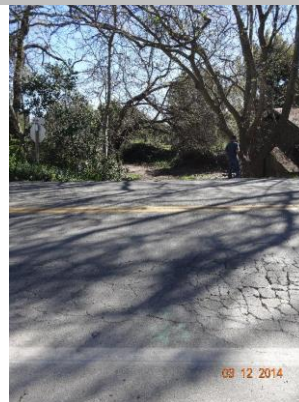
Photo 2 of 2 : UCIP_SP_2016_32022_58479.jpg

View of levee crown.

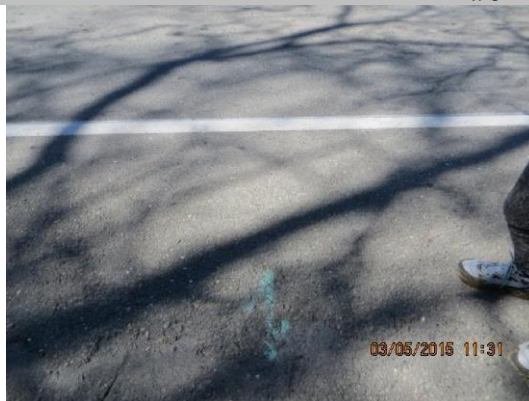
Photo 1 of 2 : UCIP_SP_2016_43804_73323.jpg

FS_ID:43804
DS_ID:25081
EP_NO: N/A
Repair Type: Non-Urgent
Crossing Status: Indicator Found
UCIP Comments: No permit identified for crossing. Further investigation required.
FIELD_STRUCT_DESC: 6-inch Sewer pipe through the levee at an unknown depth. USAA markings on pavement indicate crossing at center of ramp on LS slope.
FS Date: 3/5/2015

USAA SS marking on LS shoulder.

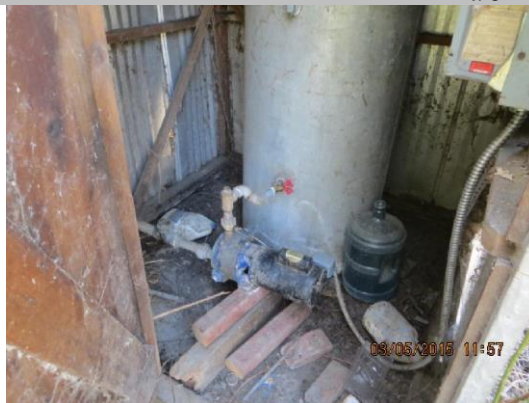
Photo 1 of 2 : UCIP_SP_2016_43806_73243.jpg

FS_ID:43806
DS_ID:20943
EP_NO: 2321
Repair Type: Urgent
Crossing Status: Indicator Found
UCIP Comments: Pipe leak at landside toe 23-ft upstream from pumphouse on LS toe.
FIELD_STRUCT_DESC: 1.0-inch steel domestic water pipe through the levee, 1.5 feet below the crown. Shut off valve on the waterward side and at the pumphouse downstream 170-feet on LS toe. (Permit No. 2321-1957). Pump in pumphouse on LS toe. an additional 1.5-inch galvanized iron drinking water pipe runs from pumphouse along LS toe parallel to levee.
FS Date: 3/5/2015

Pressurized tank, meter and pump in pumphouse on LS toe.

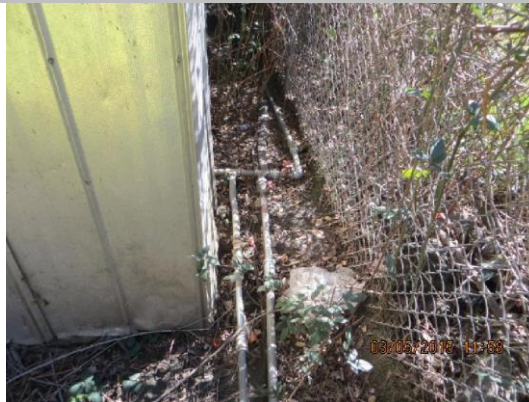
Photo 2 of 2 : UCIP_SP_2016_43806_73244.jpg

A 1-inch and a 1.5-inch galvanized iron drinking water pipe with shutoff valves at pumphouse on landside toe.

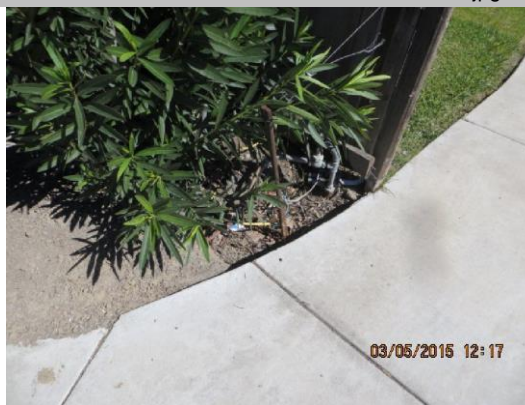
Photo 1 of 2 : UCIP_SP_2016_43810_73328.jpg

LM Start	1.09	Rating **	M	Issue No.	49
LM End	1.09	Issue Type +	En	Location *	WS
Category	Supplemental			GPS Latitude/Longitude	
				Start	End
Item	DWR UCIP Field Study			38.235743 °	38.235743 °
				-121.517032 °	-121.517032 °
DWR ID					
Comment Code					
Inspector Comment					
FS_ID:43810 DS_ID:25083 EP_NO: N/A Repair Type: Non-Urgent Crossing Status: Found UCIP Comments: No permit identified for crossing. Further investigation required. FIELD_STRUCT_DESC: Two 1-inch conduits through the levee 1-foot below the crown. Valves appear to be installed on LS shoulder. Dock on WS slope. FS Date: 3/5/2015

Pipes visible at LS shoulder next to driveway.

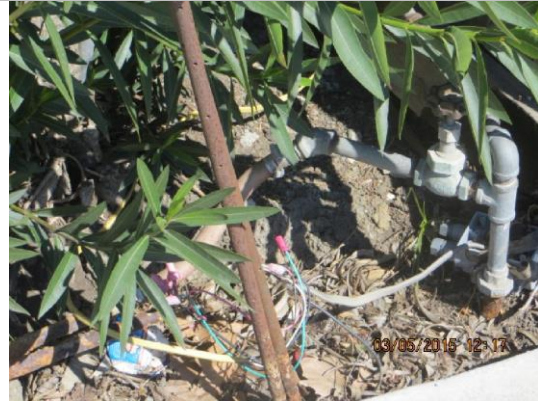
Photo 2 of 2 : UCIP_SP_2016_43810_73329.jpg

LM Start	1.09	Rating **	M	Issue No.	49 (cont)
LM End	1.09	Issue Type +	En	Location *	WS
Category	Supplemental			GPS Latitude/Longitude	
				Start	End
Item	DWR UCIP Field Study			38.235743 °	38.235743 °
				-121.517032 °	-121.517032 °
DWR ID					
Comment Code					
Inspector Comment					
FS_ID:43810 DS_ID:25083 EP_NO: N/A Repair Type: Non-Urgent Crossing Status: Found UCIP Comments: No permit identified for crossing. Further investigation required. FIELD_STRUCT_DESC: Two 1-inch conduits through the levee 1-foot below the crown. Valves appear to be installed on LS shoulder. Dock on WS slope. FS Date: 3/5/2015

Pipes and valves visible on LS shoulder.

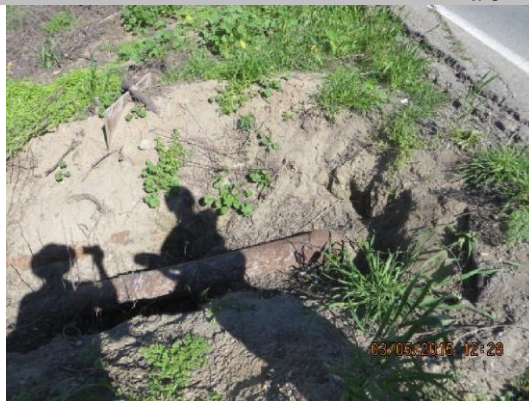
Photo 1 of 2 : UCIP_SP_2016_43748_73289.jpg

LM Start	1.11	Rating **	M	Issue No.	53
LM End	1.11	Issue Type +	En	Location *	WS
Category	Supplemental			GPS Latitude/Longitude	
				Start	End
Item	DWR UCIP Field Study			38.235422 °	38.235422 °
				-121.517172 °	-121.517172 °
DWR ID					
Comment Code					
Inspector Comment					
FS_ID:43748 DS_ID:20911 EP_NO: 5023 Repair Type: Non-Urgent Crossing Status: Found UCIP Comments: Pipe in open trench on WS slope and exposed on LS shoulder. Pipe repair on WS may indicate problem with pipe. Pipe missing air releif valve on LS shoulder. Distribution box on LS toe abandoned. FIELD_STRUCT_DESC: 8-inch steel pipe through the levee, 2.4 feet below the crown. Cutoff wall around center of pipe. Air-relief valve on landward levee shoulder. Pump on waterward slope. Concrete distribution box on LS toe (Permit No. 5023-1965). FS Date: 3/5/2015

Pipe in open trench on WS slope. Repair patch on pipe.

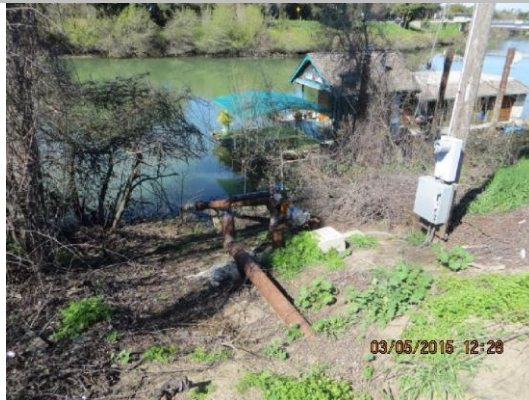
Photo 2 of 2 : UCIP_SP_2016_43748_73288.jpg

Pipe exposed on WS slope. pump, shutoff valve, and meter on pole on WS slope.
